Manhole Inspection Summary

Manhole # S47KK_043MH

Insp Date: **5/5/08 8:26 AM**

Location Address: **Gay St**

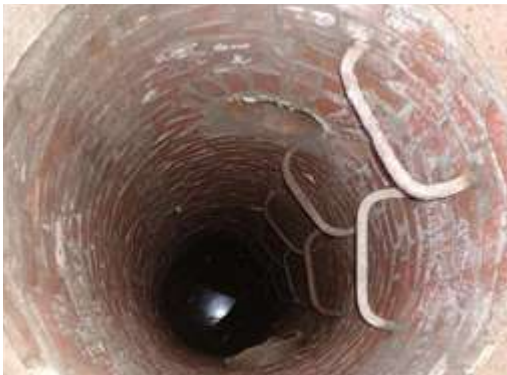
Defect 3

infiltration

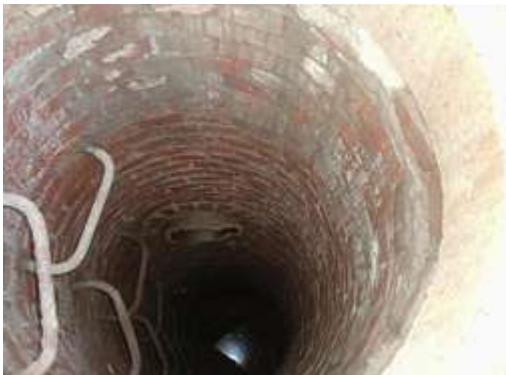
Defect 2

infiltration

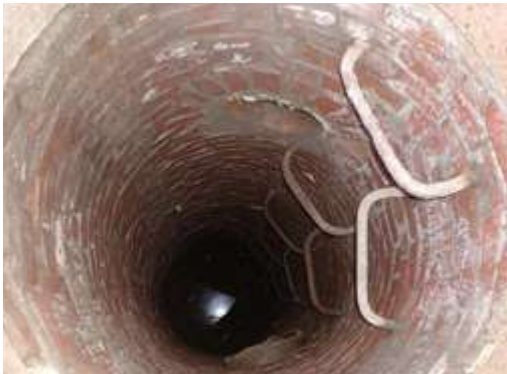
Defect 1

frame leaks

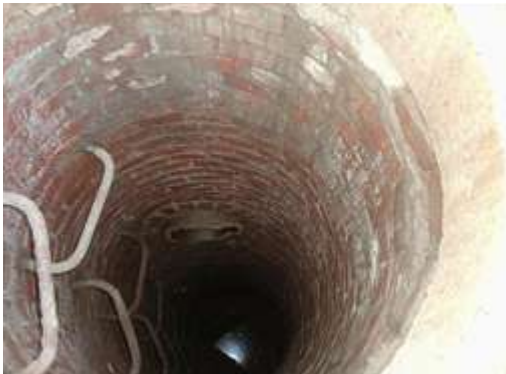
Defect 4

frame leaks

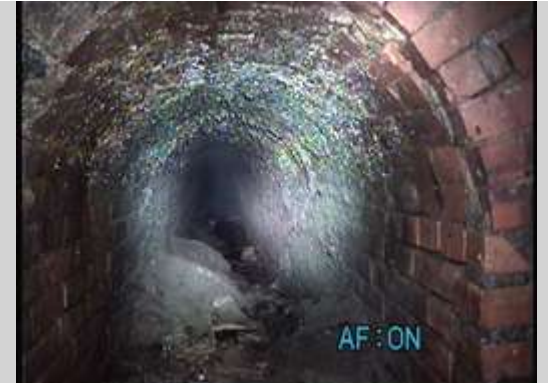
12 O'Clock Outflow

Pipe Height: **33.6** (in.) Rod and Bar (Angled)
Pipe Material: **Clay** ☐ Pipe Lined
Invert Depth: **24.20** (ft.) Flow Characteristics: **None**
Deposits: ☒ None ☐ Mud ☐ Sludge ☐ Debris ☐ Grease
Silt Depth: (in.) Deposits Extent:
Infiltration: **None** Pipe Seal Cond: **Sound**

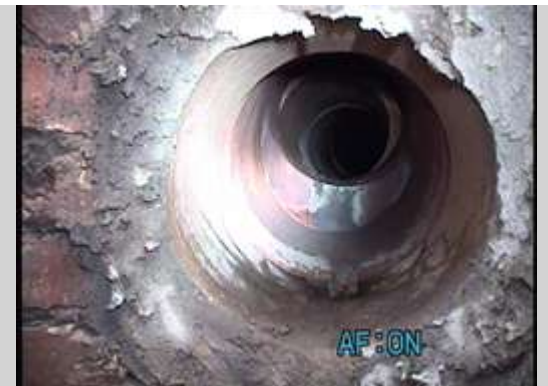
3 O'Clock Inflow

Pipe Height: **10.8** (in.) Rod and Bar (Angled)
Pipe Material: **Clay** ☐ Pipe Lined
Invert Depth: **4.00** (ft.) Flow Characteristics: **None**
Deposits: ☒ None ☐ Mud ☐ Sludge ☐ Debris ☐ Grease
Silt Depth: (in.) Deposits Extent:
Infiltration: **None** Pipe Seal Cond: **Sound**

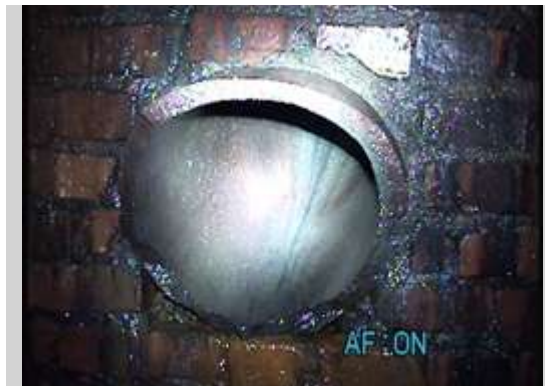
Drop In @ 3 O'Clock

Drop: **Inside** Rod and Bar
Angled: **Yes** Reading: **22.65** (ft.)
Inv Depth: **23.65** (ft.)
Drop Condition: **Open**

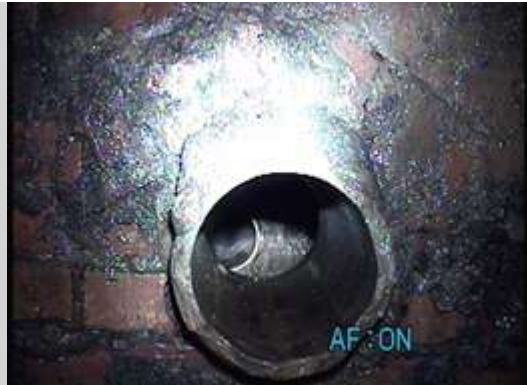
6 O'Clock Inflow

Pipe Height: **8.4** (in.) Rod and Bar (Angled)

Infiltration: **None**

Pipe Seal Cond: **Sound**

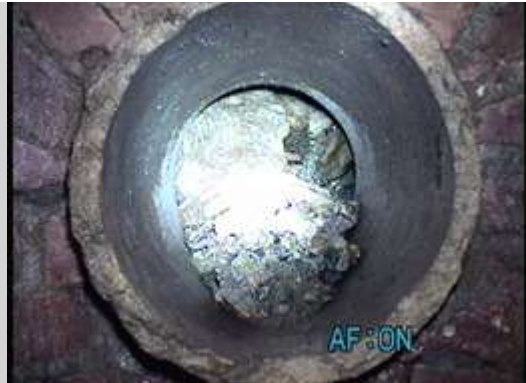
9 O'Clock Inflow

Pipe Height: **10.8** (in.) Rod and Bar (Angled)

Infiltration: **None**

Pipe Seal Cond: **Sound**

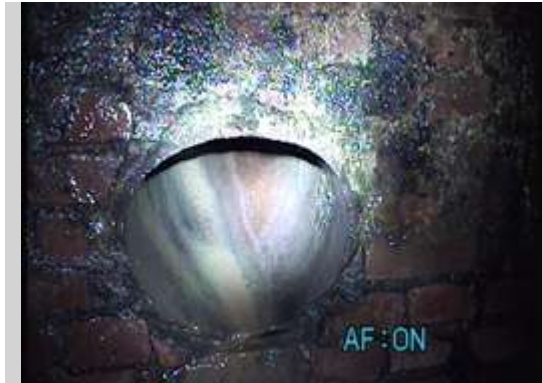
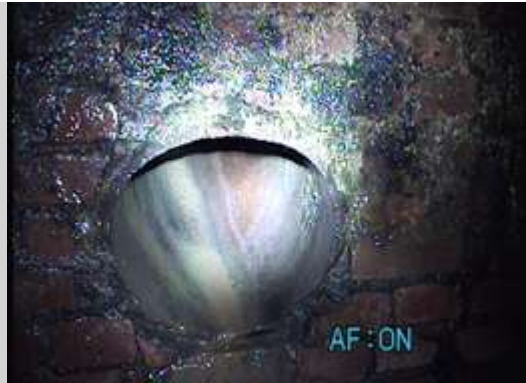
Drop In @ 9 O'Clock

| Drop: Inside | Rod and Bar |
| Drop Condition: Open | |
